SURVEY REPORT

Meadow Lark

Vessel type	Narrowboat
Survey purpose	Pre-Purchase
Date of survey	26 April 2026

Coastal Marine Surveys Ltd

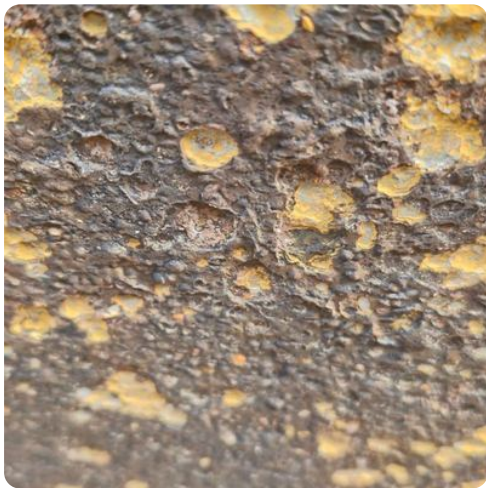
The hull plating above the waterline is in good condition. No significant distortion, buckling, or pitting was observed. Two minor areas of surface rust were noted on the port side chine (each approximately 150mm in extent); these are cosmetic in nature and present no structural concern. Rubbing strakes are in good condition throughout, with typical minor scuffing consistent with normal lock and mooring use. Paint is intact at all rubbing strake locations.

UTT readings were recorded at 28 locations across the hull during the out-of-water inspection. Baseplate readings (original specification 10mm) ranged from 9.3mm to 9.9mm across all sections from bow to stern. Shell plating readings (original specification 6mm) ranged from 5.7mm to 6.1mm on both port and starboard sides and at the chines. All readings are within acceptable limits for insurance purposes. No spray foam insulation was present, ensuring full UTT access throughout the vessel. Internal inspection of the bilge via the engine bay and floor hatches revealed minimal water accumulation, no active leaks, and only superficial surface rust on the internal baseplate, consistent with age and normal condensation.

Minor surface rust at two locations on the port side chine (approximately 150mm each) and minor paint scuffing at two locations on the gunwales and rubbing strakes should be treated and touched up at the next repaint as a matter of routine maintenance. No structural significance is attached to these items.

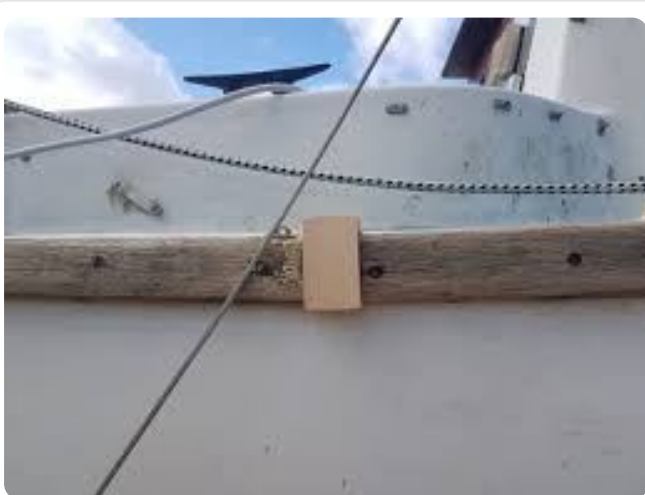
The continuous full-length roof handrail is secure throughout, with no movement detected at any fixing point. Base plates show no significant corrosion, and the handrail provides good support for working locks. Gunwales are in good condition with protective paint intact. Rubbing strakes show typical minor wear at two locations where paint touch-up would be beneficial at the next repaint; these are cosmetic matters only.

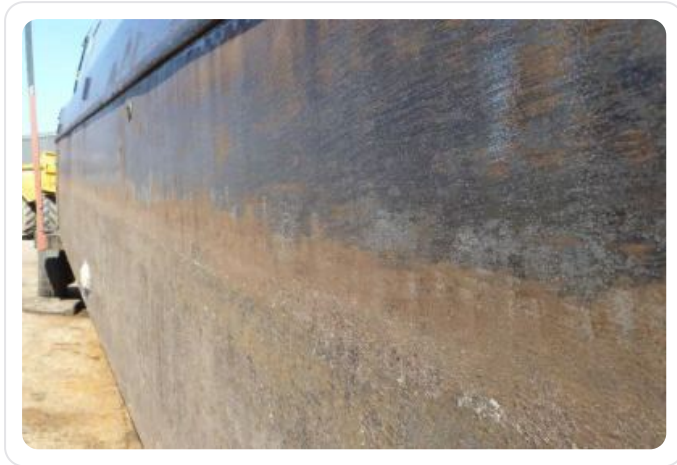
The bituminous blacking (two-coat) was applied in October 2023 and, at the time of inspection, was approximately 18 months old. The coating is in very good condition with intact, uniform coverage across the baseplate and sides. No bare patches, bubbling, or delamination were observed. The blacking retains significant remaining life; however, reapplication should be planned for approximately 2025/2026, which coincides with the recommended reapplication and anode inspection interval. This item is noted as a Category B maintenance item.

3. Blacking reapplication. The current bituminous blacking was applied in October 2023 and remains in very good condition. However, reapplication should be planned for approximately 2025/2026 in line with the standard two-year interval for a vessel in regular leisure use. The haul-out for blacking should be combined with inspection and replacement of the sacrificial anodes as required. The surveyor recommends maintaining the current practice of two-coat bituminous blacking.

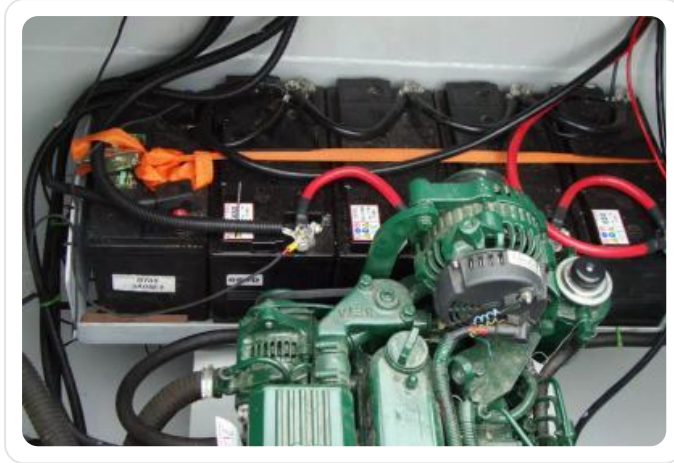
The propulsion system is an Isuzu 3LD1 (42hp) diesel engine installed new in 2012 and reading 1,943 hours on the engine hour meter. The engine bay is clean, with no evidence of oil, coolant, or fuel leaks. Engine mounts are in good condition with no visible deterioration, and alignment with the propshaft appears correct. The engine was started and ran smoothly at idle for approximately fifteen minutes, producing no unusual noises, vibration, or smoke. Engine hours appear credible relative to the overall condition and the service records provided.

The PRM 150 gearbox shows no leaks; oil level is correct and the oil is clean with no contamination. Engine oil is correct in level and was changed at the 1,900-hour service. Coolant is correct in level and is clean with no oil traces or contamination suggestive of head gasket failure.

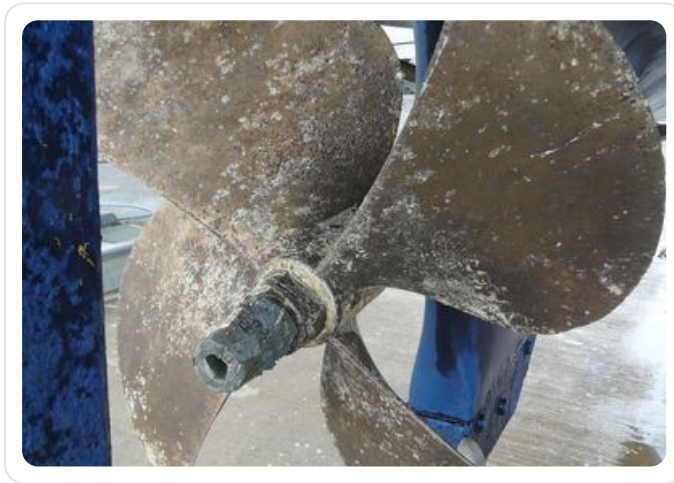
The propshaft runs true with no visible wear. The sterntube greaser is functional and was recently lubricated. The packing gland was observed to exhibit slight weeping at approximately one drip per three seconds when running — this is at the upper boundary of what may be considered acceptable but should be monitored and the gland repacked within the next twelve months. This is recorded as a Category B defect. The propeller is a three-blade bronze unit; all blades are in good condition with no damage or corrosion visible. The weed hatch lid, seal, hinge, and drain are all in good condition.

1. Packing gland repacking. The stern gland was observed to weep at approximately one drip per three seconds during the engine run, placing it at the upper boundary of acceptable limits. The gland should be repacked within the next twelve months; this is a straightforward task for any competent inland waterways boatyard and represents minimal expenditure. The rate of weeping should be monitored in the interim. Should the rate increase, the work should be brought forward accordingly.

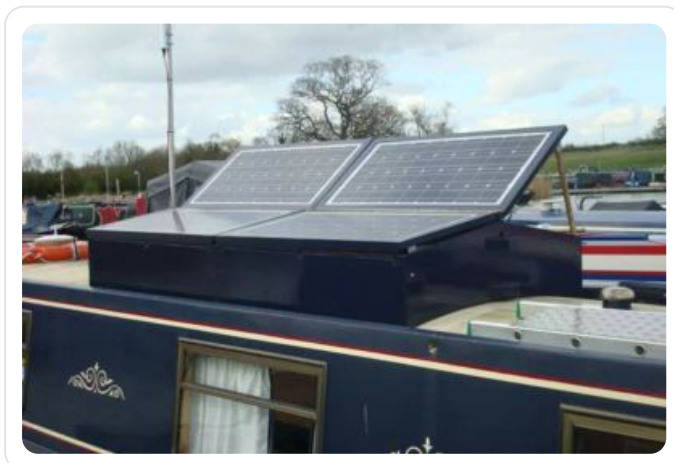
Two 200W solar panels (total 400W) are mounted on the roof with secure aluminium frames; all mounting brackets are secure with good sealant and wiring runs through sealed roof glands. The Victron SmartSolar MPPT 75/15 charge controller (installed 2024) is functioning correctly and showed active charging during the inspection. The system is well-specified for leisure use. No defects were identified within the DC electrical system.

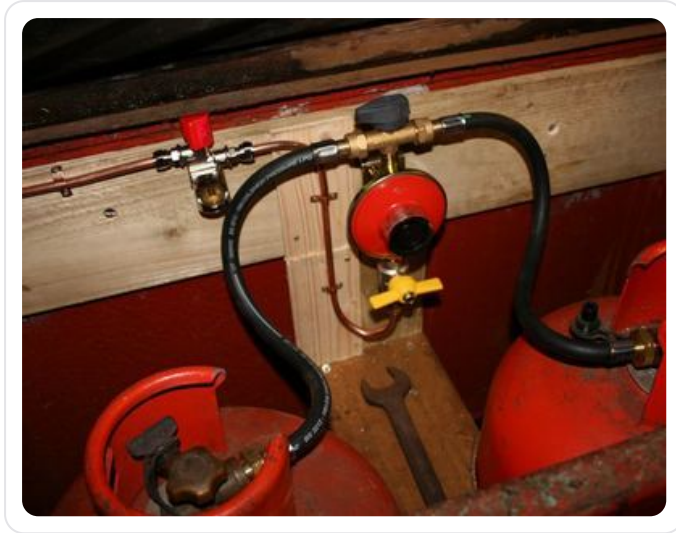
The gas regulator is a 30mbar two-stage type installed in 2015 and is therefore approximately eleven years old at the date of inspection. Whilst the regulator was found to be functional, many manufacturers recommend replacement after ten years as a precautionary measure. Replacement is recommended; budget approximately £40–£80 for the regulator and fitting. This item is recorded as a Category B defect.

2. LPG regulator replacement. The gas regulator is a 30mbar two-stage unit installed in 2015 and is therefore approximately eleven years old at the date of this survey, exceeding the ten-year recommended service life cited by many manufacturers. Although the regulator was found to be functional, replacement is strongly recommended as a precautionary measure. Budget approximately £40–£80 for a replacement regulator and fitting by a competent person. This should ideally be completed prior to the next BSS examination in September 2027.

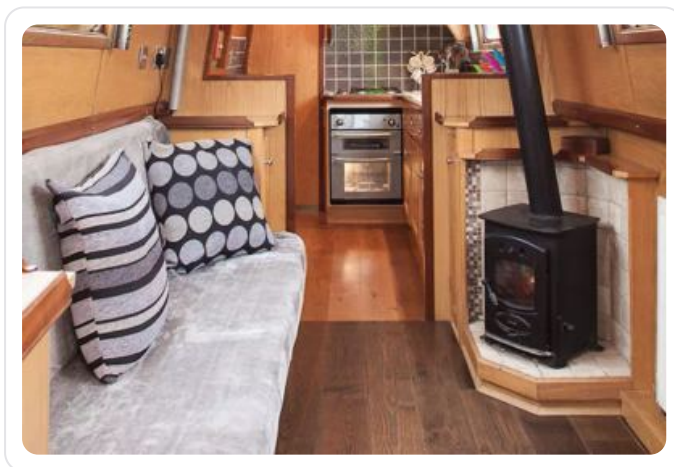
Heating is provided by a Morso Squirrel 1412 multifuel stove (5kW) installed in the saloon. The stove is in good condition: door seals are sound, the glass is intact with no cracks, and the grate and ash pan are functional. The manufacturer's plate is present. The flue pipe is of the twin-wall insulated type, runs vertically through the roof, and maintains adequate clearances to combustibles throughout (greater than 450mm). Support brackets are secure. No deterioration or corrosion was observed on the flue pipe. The chimney extends 650mm above roof level, which is adequate. A stainless steel cap in good condition is fitted, with a mesh-type spark arrestor present. The chimney is secure, with a storm collar and sealed roof penetration.

A fixed 100mm diameter combustion air vent is located in the cabin side in the vicinity of the stove. The vent is non-closeable (correctly — no butterfly or slide mechanism is fitted), unobstructed, and in good condition. This arrangement complies with BSS requirements for combustion air supply to solid fuel appliances. No diesel heating system is fitted to this vessel (recorded as N/A). No defects were identified within the heating system.

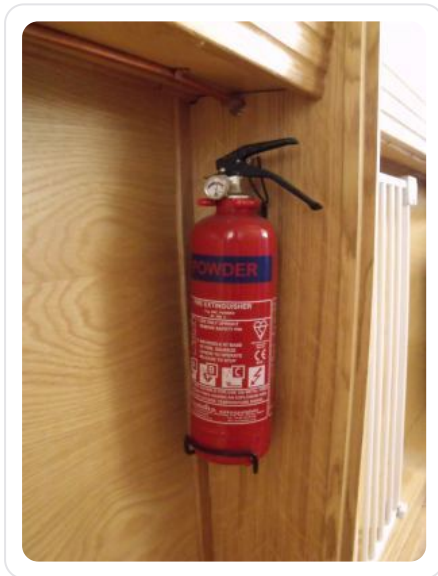
Safety equipment is present in good order. Three fire extinguishers are provided: a 2kg dry powder unit in the saloon (gauge in the green sector, last serviced 2024), a 1kg dry powder unit in the engine bay (gauge in the green sector, last serviced 2024), and a fire blanket in the galley in good condition. All extinguishers are within their service dates. Two smoke alarms are fitted — one in the saloon and one in the bedroom — both tested using the test button and both alarming correctly; both are within date (installed 2022) and are appropriately positioned on the ceiling. A CO alarm is fitted in the bedroom (sleeping area) in compliance with BSS requirements, positioned at head height. The unit was tested and alarms correctly, and is within date (installed 2022). Navigation lights were tested and are all operational: port (red), starboard (green), stern (white), and masthead (white) — all LED type and in good condition. No defects were identified within the safety equipment inventory.

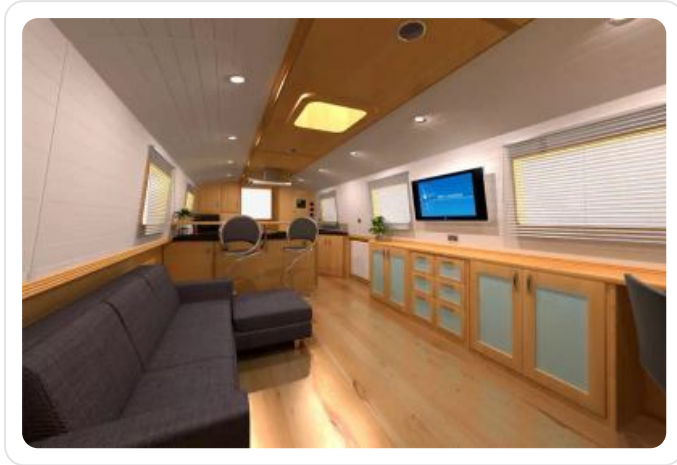
The internal fit-out is of high quality, featuring solid oak joinery throughout and tongue-and-groove oak linings with Celotex rigid foam board insulation. The use of Celotex rather than spray foam is specifically noted as a positive characteristic: it preserves full future UTT access and has no adverse implications for insurability or resale value. No evidence of moisture ingress, condensation staining, or damp was found anywhere in the interior. Internal hull surfaces, inspected via the engine bay and under-floor access hatches, show only superficial surface rust consistent with age — there is no active corrosion. All roof penetrations were verified from the interior with no water staining or evidence of any ingress.
